## Market Information

### ABS sensor Repair Units

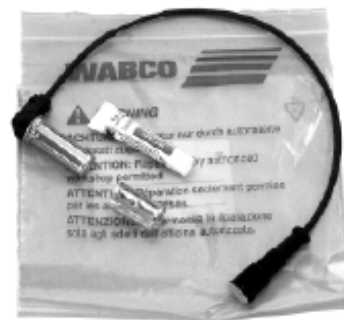
The sensor and the clamp bushing should always be replaced and fitted with the special grease during servicing.
